LOWER ST. CROIX NATIONAL WILD AND SCENIC RIVER ORDINARY HIGH WATER MARK

Ordinary High-Water Mark

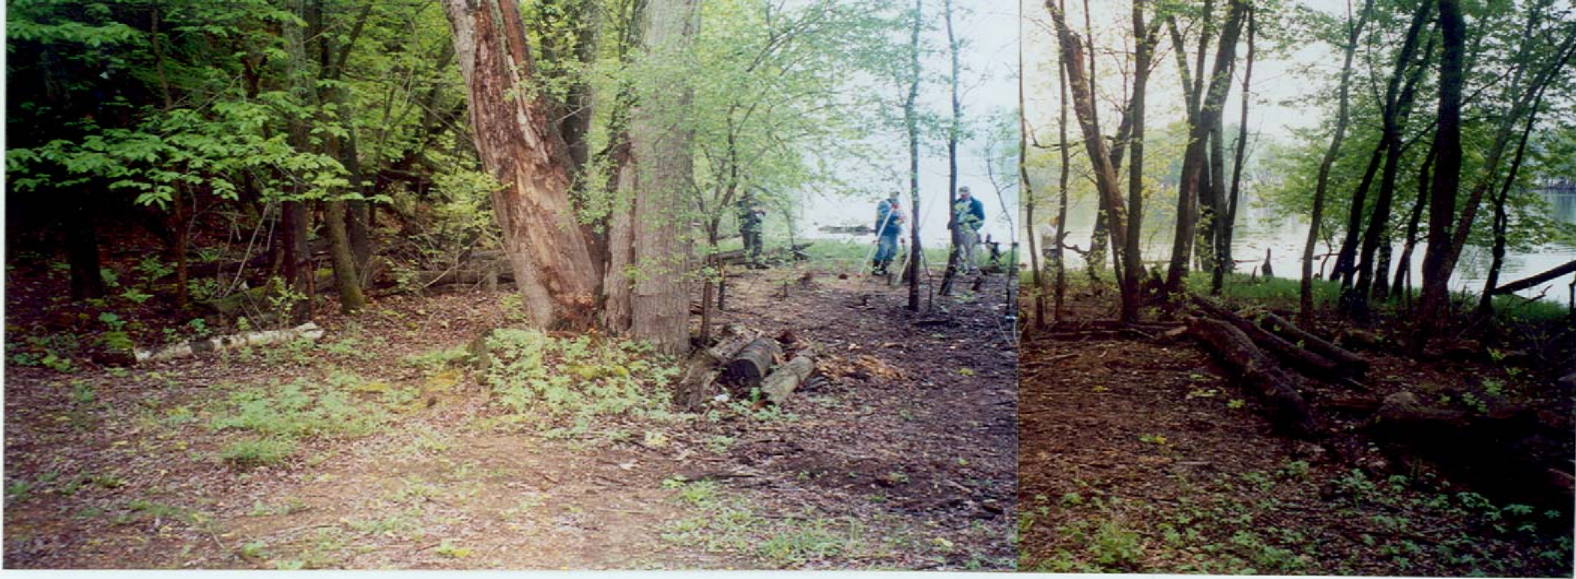
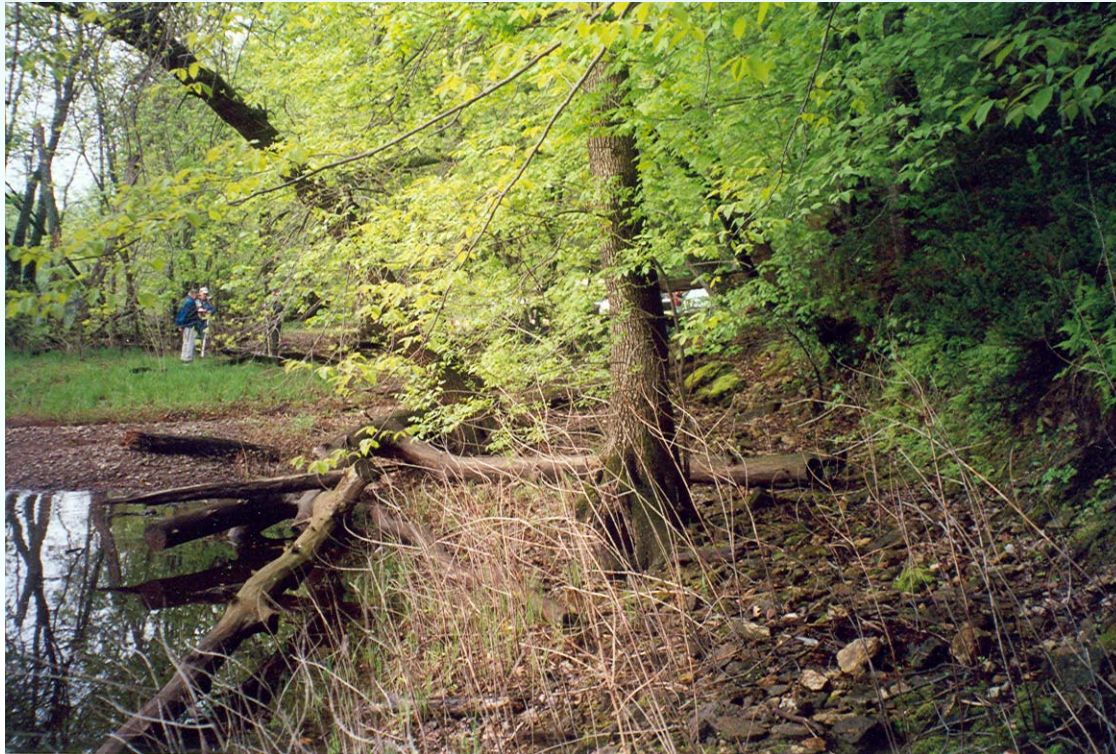
TWIN SPRINGS

TRANSECT 1

The biological indicators we found here were one pipe elbow root and multiple tree trunks on several trees

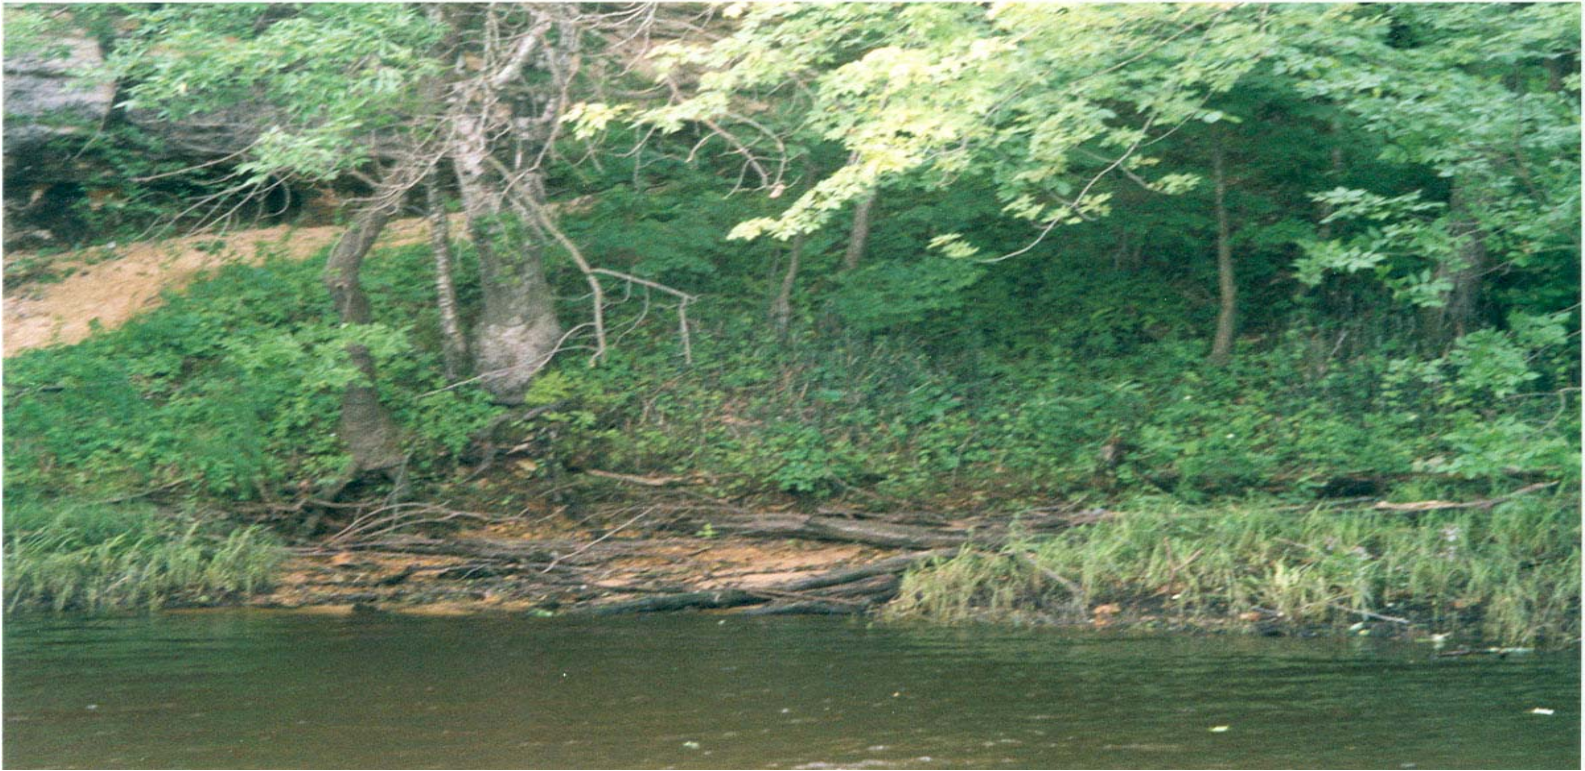
TWIN SPRINGS---TRANSECT 2

The erosion line and exposed tree roots are both examples of physical indicators that we look for to find the OHWM.

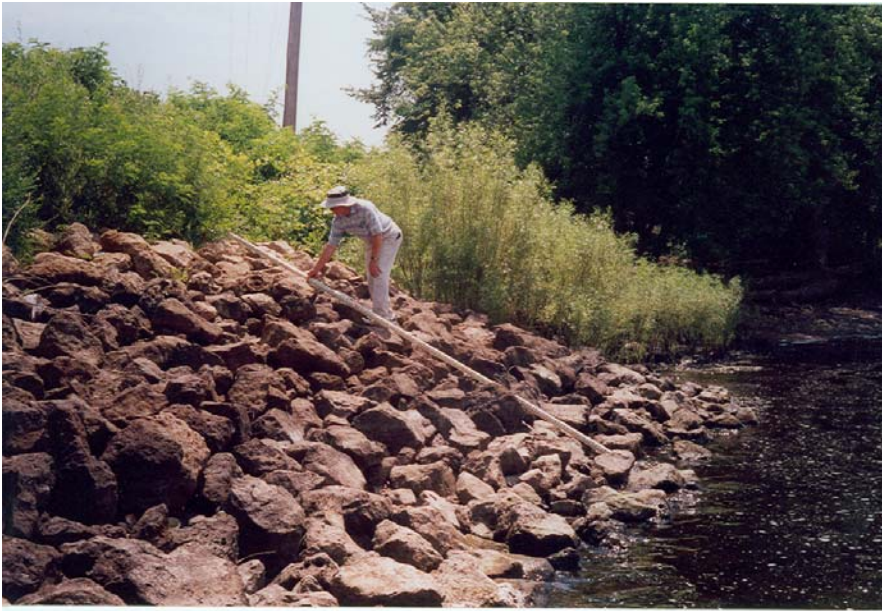
LAKE MALLALIEU DAM

The water stain on the dam is an excellent physical indicator.

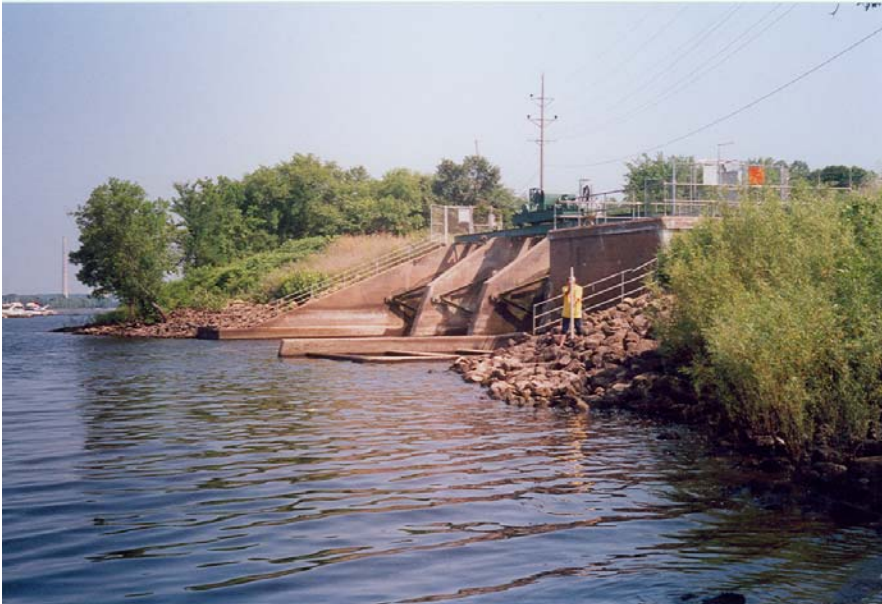
OHWM - biological and physical

SOME
INDICATORS WE
FOUND ON THE
ST CROIX:

Multiple tree
trunks

Exposed roots

Shallow roots

Cobble drift line

Hydric vegetation

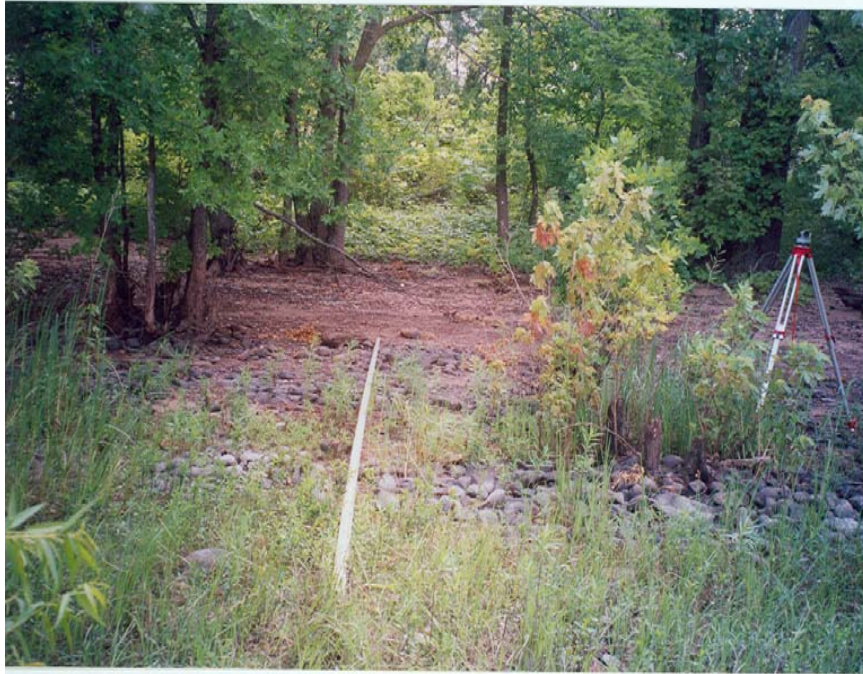
UNION PACIFIC RAILROAD PROPERTY

Notice the multiple tree trunks, shallow root systems and water dependent vegetation-all good biological indicators.

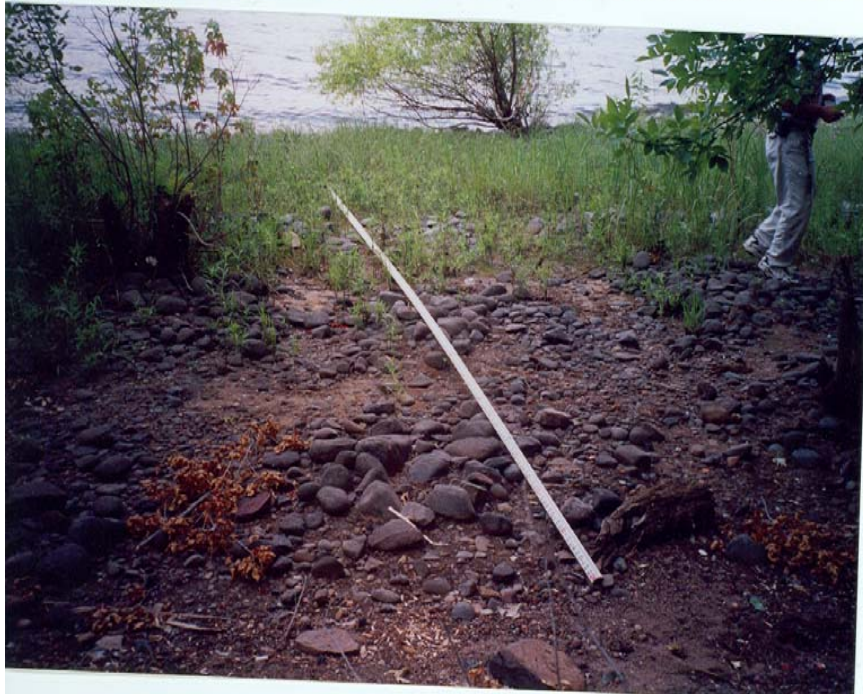
The exposed tree roots and cobble drift lines are good physical indicators.

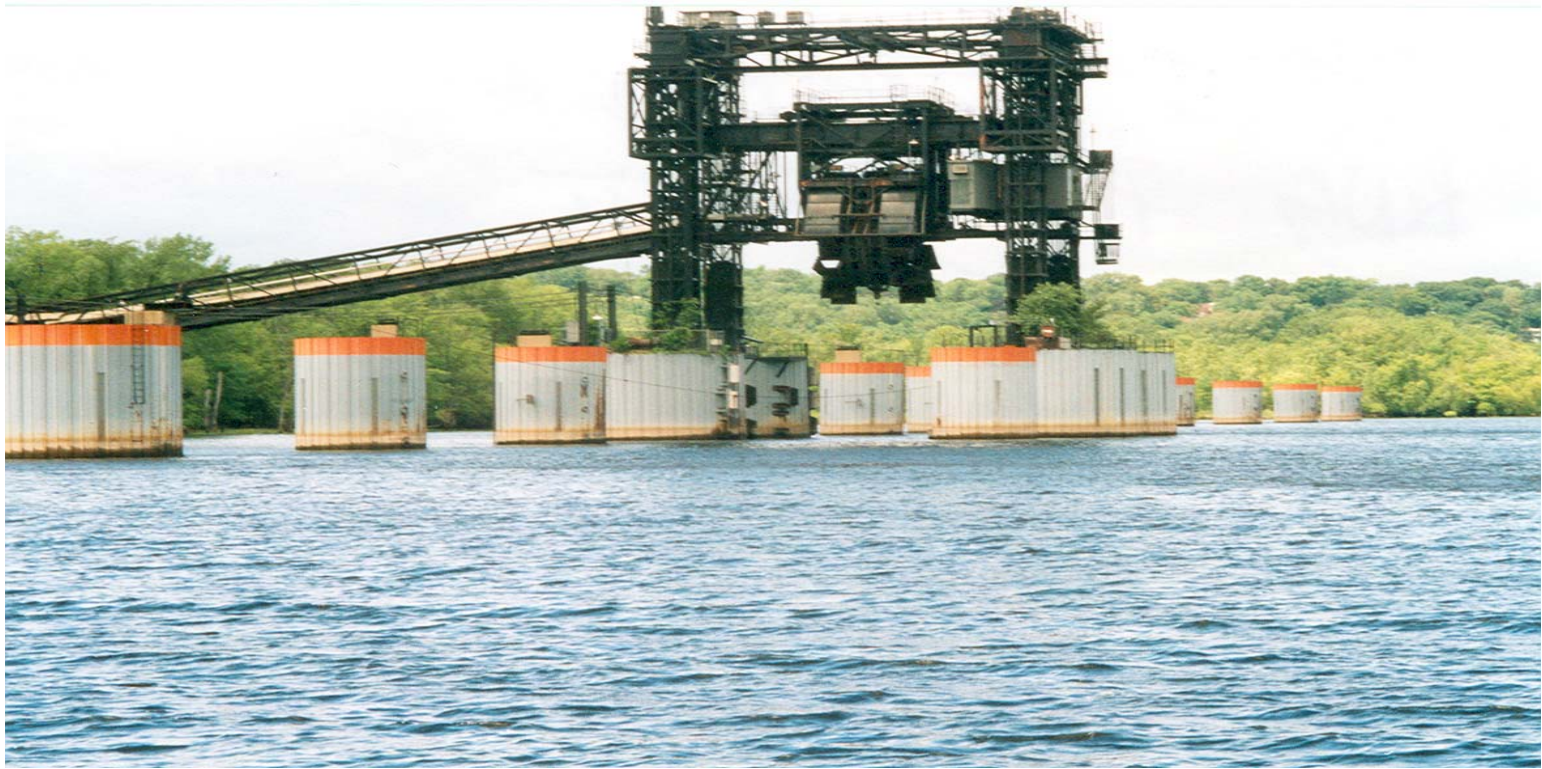
BARGE DOLPHINS AT THE KING POWER PLANT

The stain line on the dolphins is a good example of both permanent and predominate.

As the indicator is a line, it is accurate as well

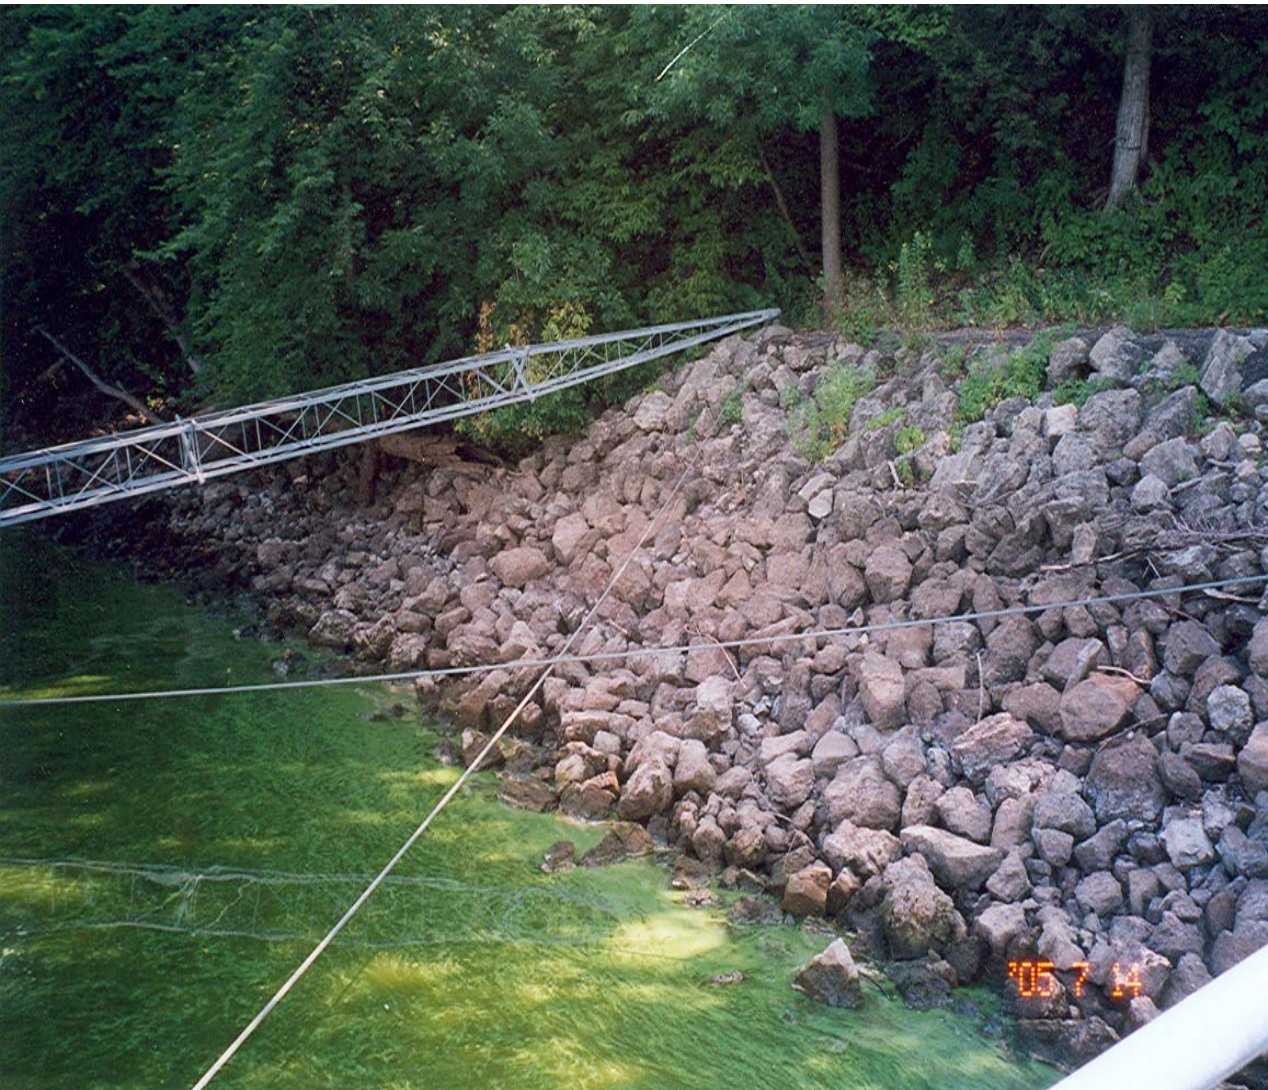
KINNICKINNIC PARK PIER AREA

The water stain is shown on both the artificial riprap and on the natural riprap---notice that this is not a break in the stain

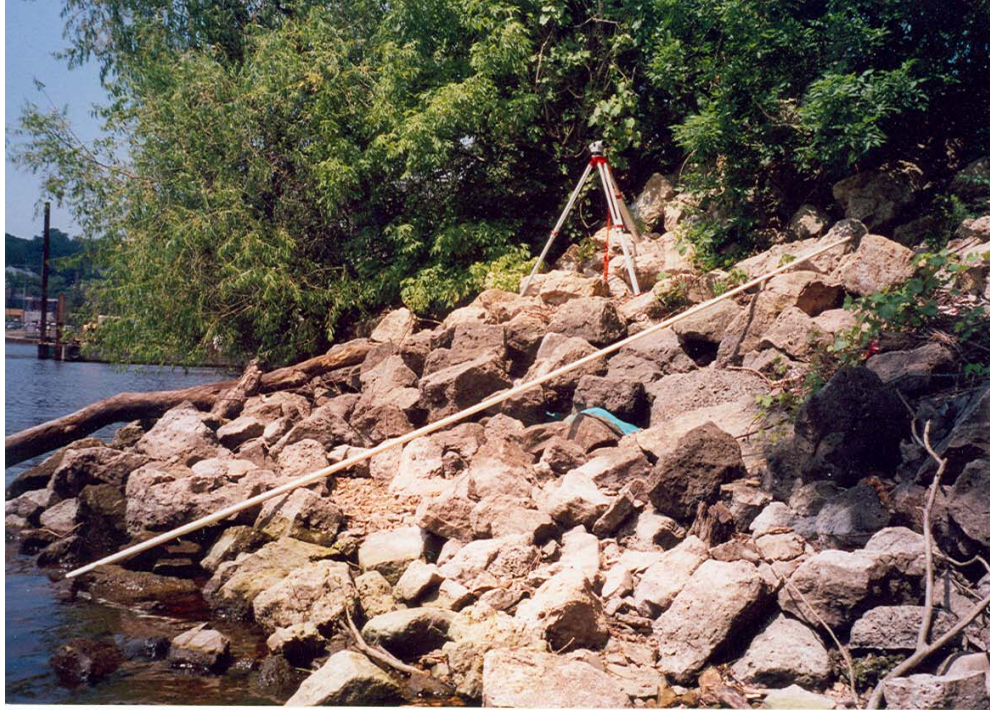
THE STILLWATER EARTHEN CAUSEWAY

Same staining pattern—

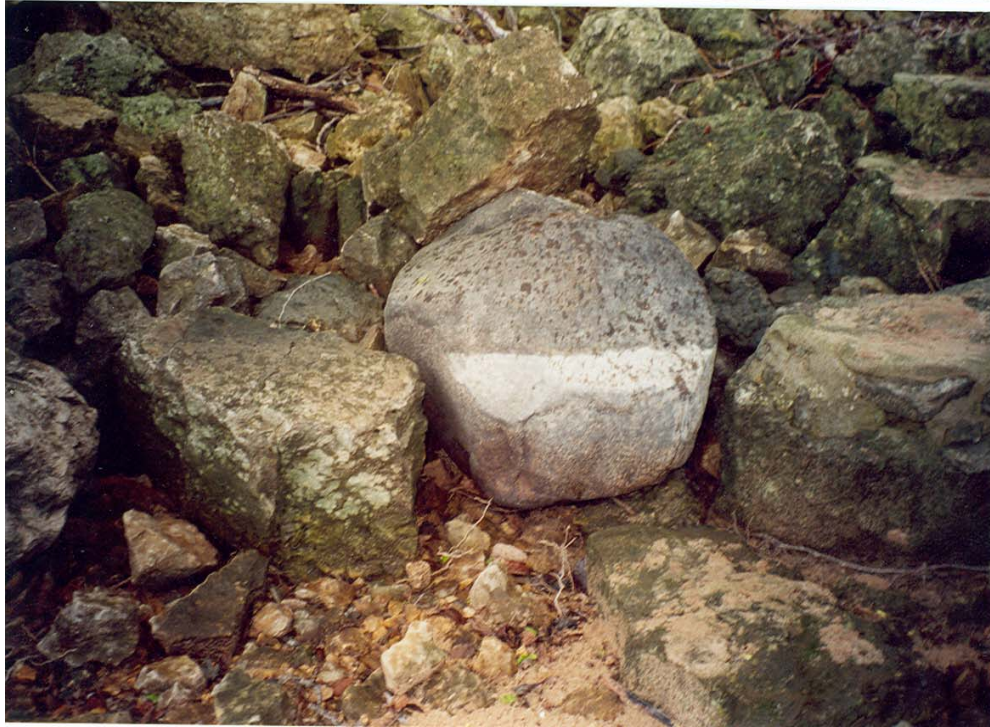
Elevation of stain is
within 0.1 foot as stated
in Ch. 40 of the
guidebook
